# RPC operation in the ATLAS experiment

Mohamed Zaazoua

November 18, 2023

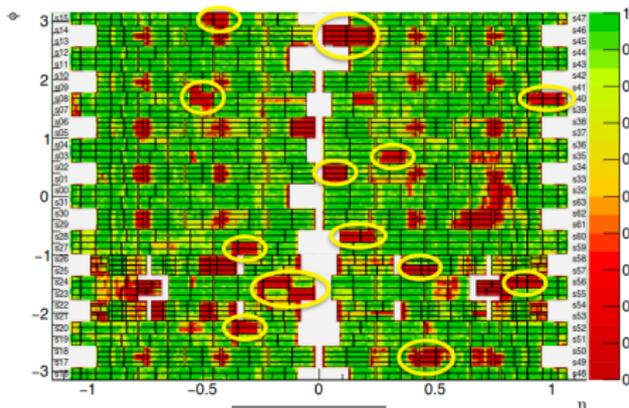
Low-pT End-of-2022

Recovered

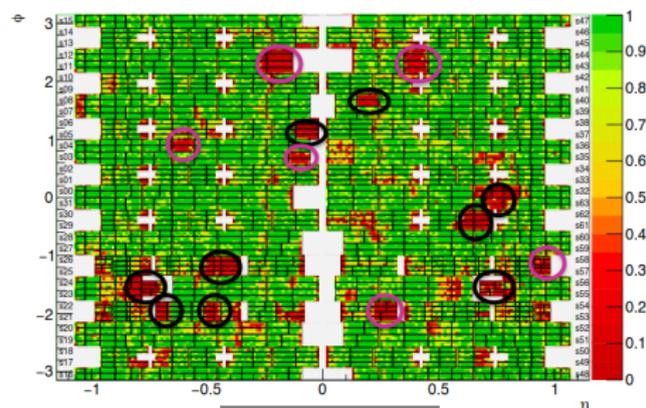
Low-pT Run 453556 (Jun 02)

Unfixed

New

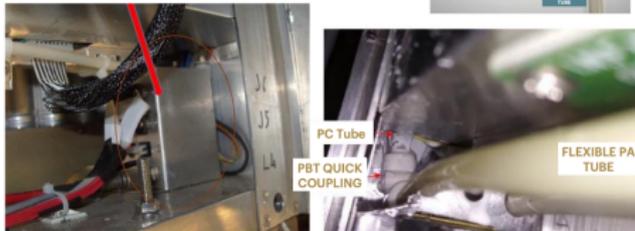
• Where these gas leaks occur?

• This connectors are installed inside aluminum boxes as shown.

- Fixing of small leaks and prevention of leaks
- Applicable when inlets are not completely cracked
- R&D still ongoing to extend the applicability to all barrel regions (e.g. vertical chambers)

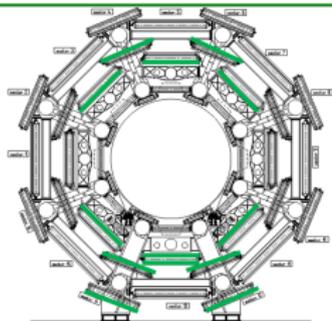
Injected boxes: 435, i.e 870 inlets (~10% of the total)

- Repair rate (determined from previous campaign)  
Resin injection rate: 60 boxes/week, i.e. 120 inlets/week (assuming 4 Istinye + other teams, 8 persons) 600 filled boxes in next YETS
- Applicability of the technique is the limiting factor.

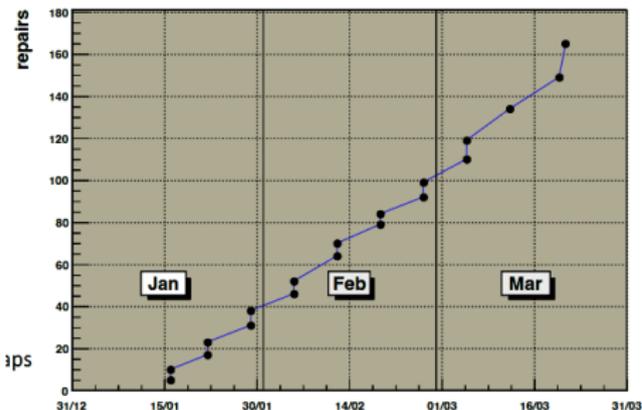
Gas leak repairs VS time

- During last YETS: 165 repair in total (16.5 repairs/week)
- Non-repairable gaps are disconnected.
- Resin injections technique may be applied.

- Glueing partially cracked inlets: spray glue.
- Replacing fully cracked inlets with a small pipe: remove the PBT QUICK coupling by small pipe that is tight toward the pipe.

First, priority is given to repairing gaps in order to address trigger holes. Subsequently, large leaky lines are addressed.
