Silicon detector test updates

2021.10.24

Kang Liu for tracker lab

Device damage condition test by IV

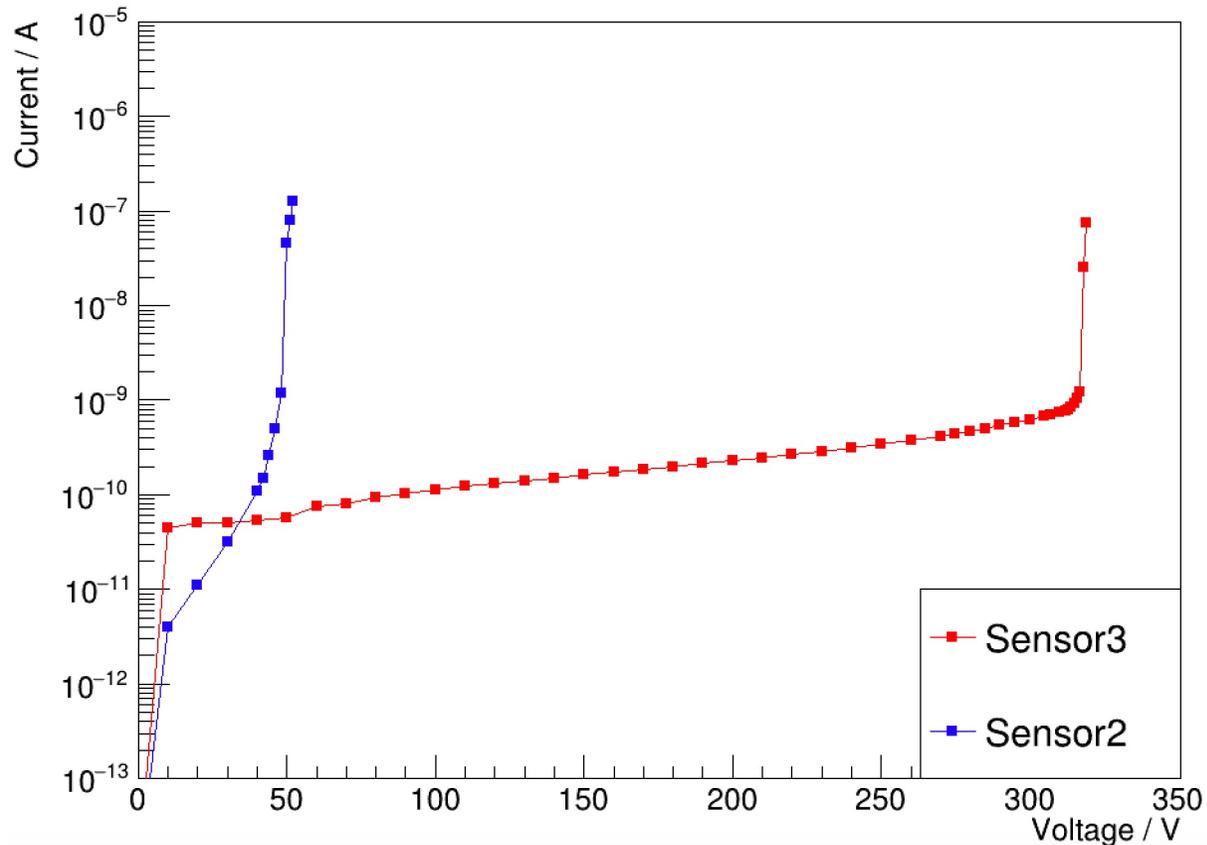
W7P14

Sensor 2 has been confirmed to be damaged
Sensor test

There is a significant difference of IV curves between sensor3 and sensor2.

sensor3	LGAD_USTC_BL
sensor2	LGAD_USTC_BL

编号	型号	状态	问题描述	备注
sensor_dirty	LGAD_USTC_FP-N	或许轻微损伤	损伤, 雪崩电压数值不稳定	
sensor4	LGAD_USTC_NPE-N	或许轻微损伤	轻微损伤, 原雪崩电压318V, 现雪崩电压310V	变温测试
sensor3	LGAD_USTC_BL	正常		变温测试
sensor2	LGAD_USTC_BL	损坏	25摄氏度下雪崩电压只有51V	
sensor1	LG1_SE5	正常		变温测试
hpk1	LG1_SE5	正常		
hpk2	LG1_SE5	正常		
hpk3	LG1_SE2	正常		
hpk4	LG1_SE5	正常但不稳定

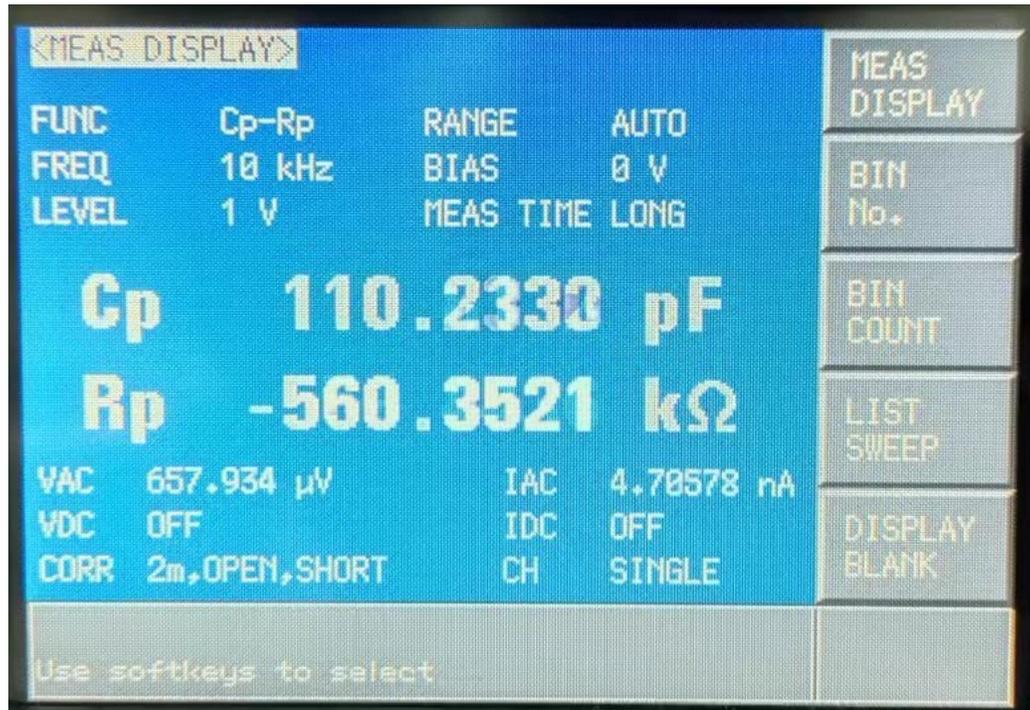
C-V test

CV 校准:

开路: 电容~百 fF; 电阻~百 M欧

短路: 电容~百 fF; 电阻~百 K欧

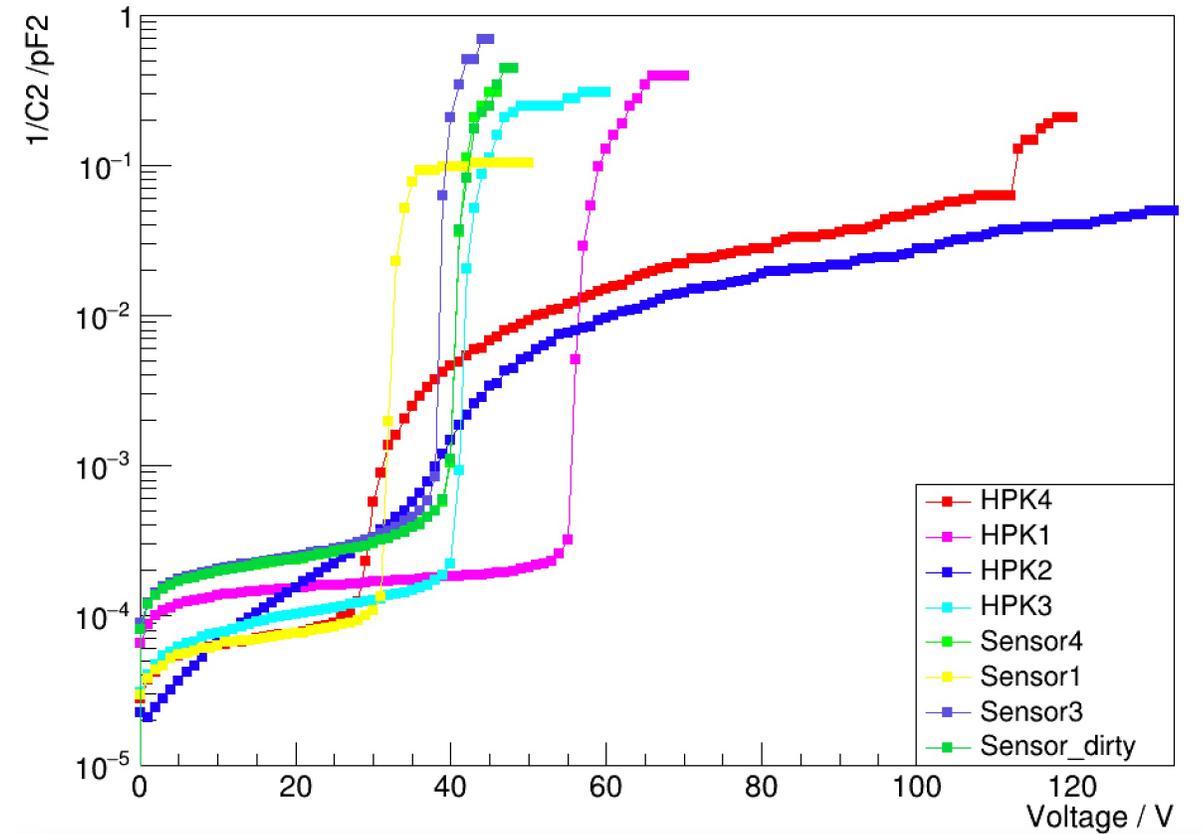
After recalibration, the measurement of small capacitance has been significantly improved
