Silicon detector test updates

2021.09.16

Kang Liu for tracker lab

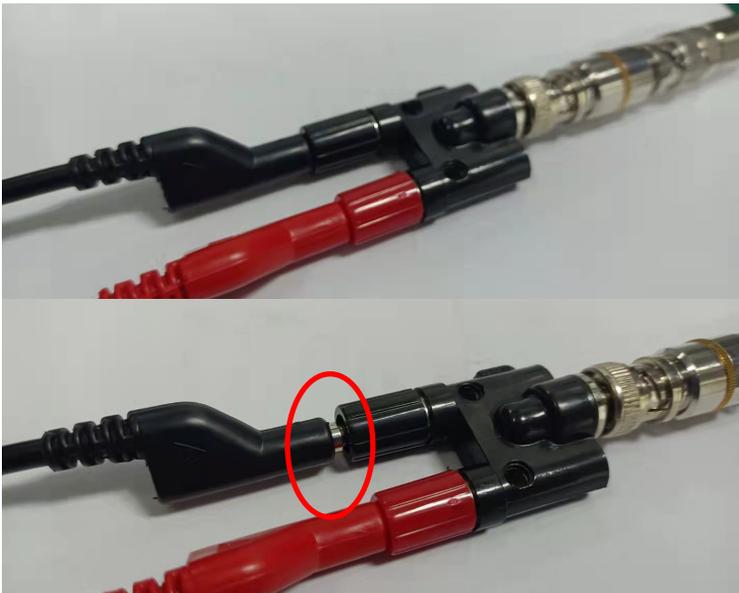
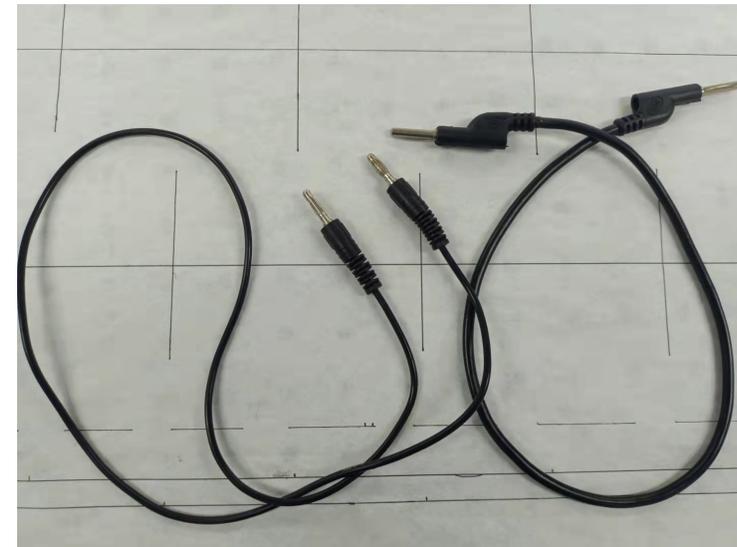
Improvement of experimental setup

Replaced the **banana jumper** that was connected to the negative electrode of the **ammeter** with poor contact.

Replaced the **thin banana jumper** connected to the negative pole of the **power supply**.

There is a difference of about **tens to 100 pA** before and after replacement.

It is necessary to ensure that each jumper is in good contact and has uniform specifications.

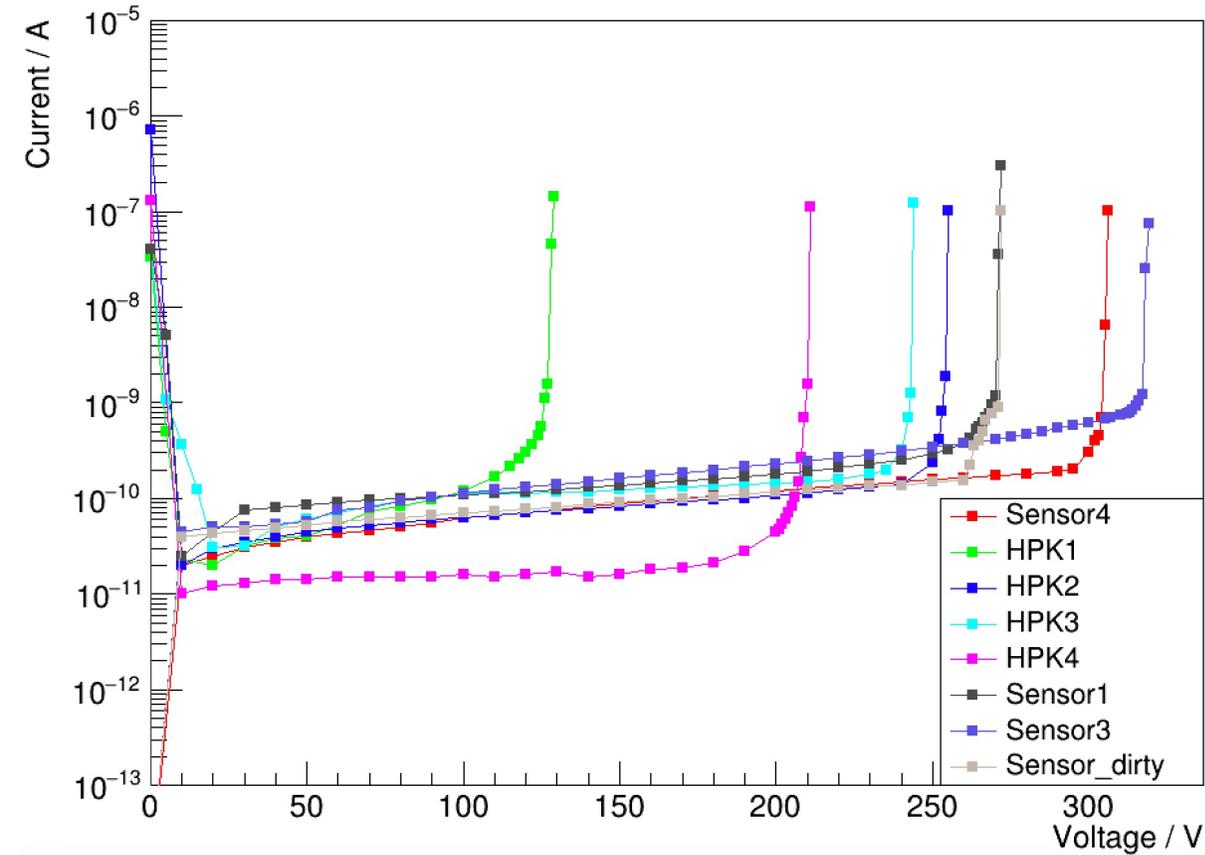
Sensor test

IV Testing result

The IV curve after the improved wiring looks more normal.

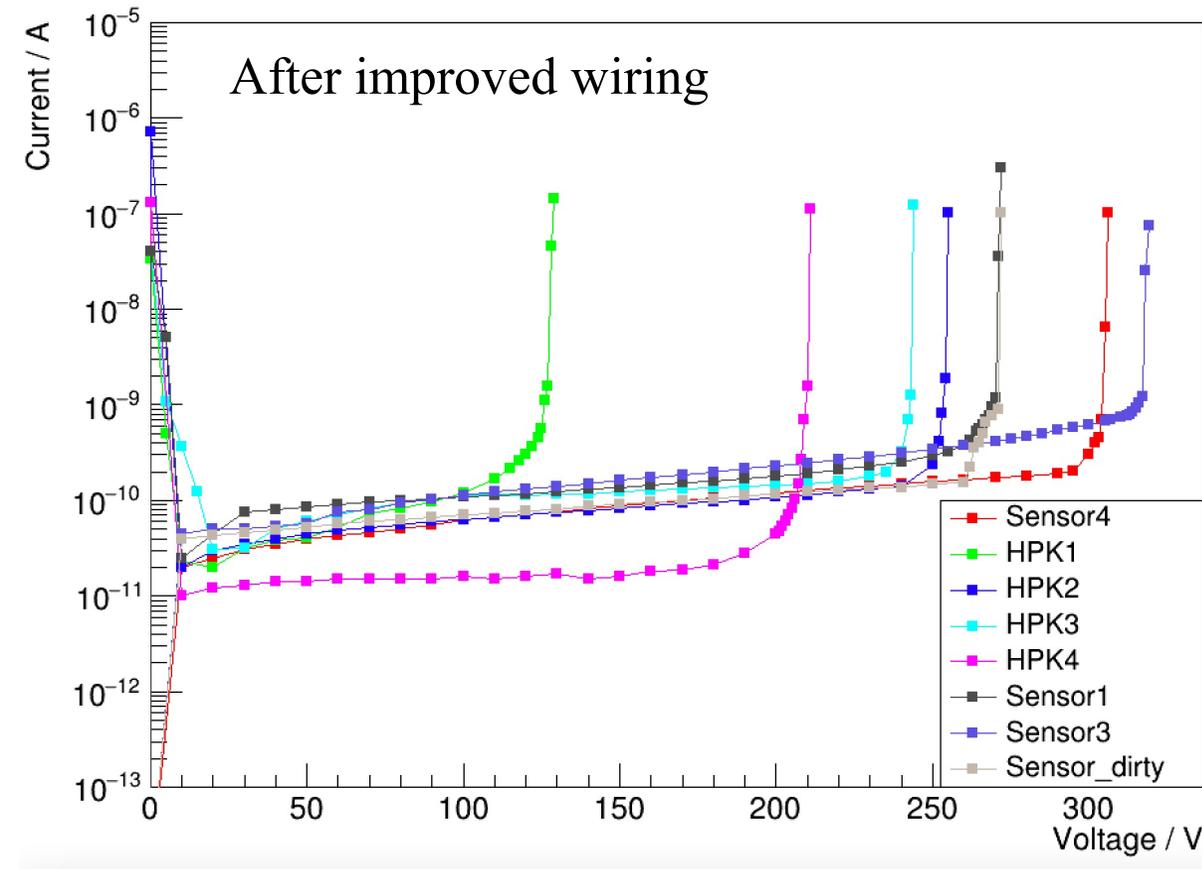
Sensor test

IV Testing result

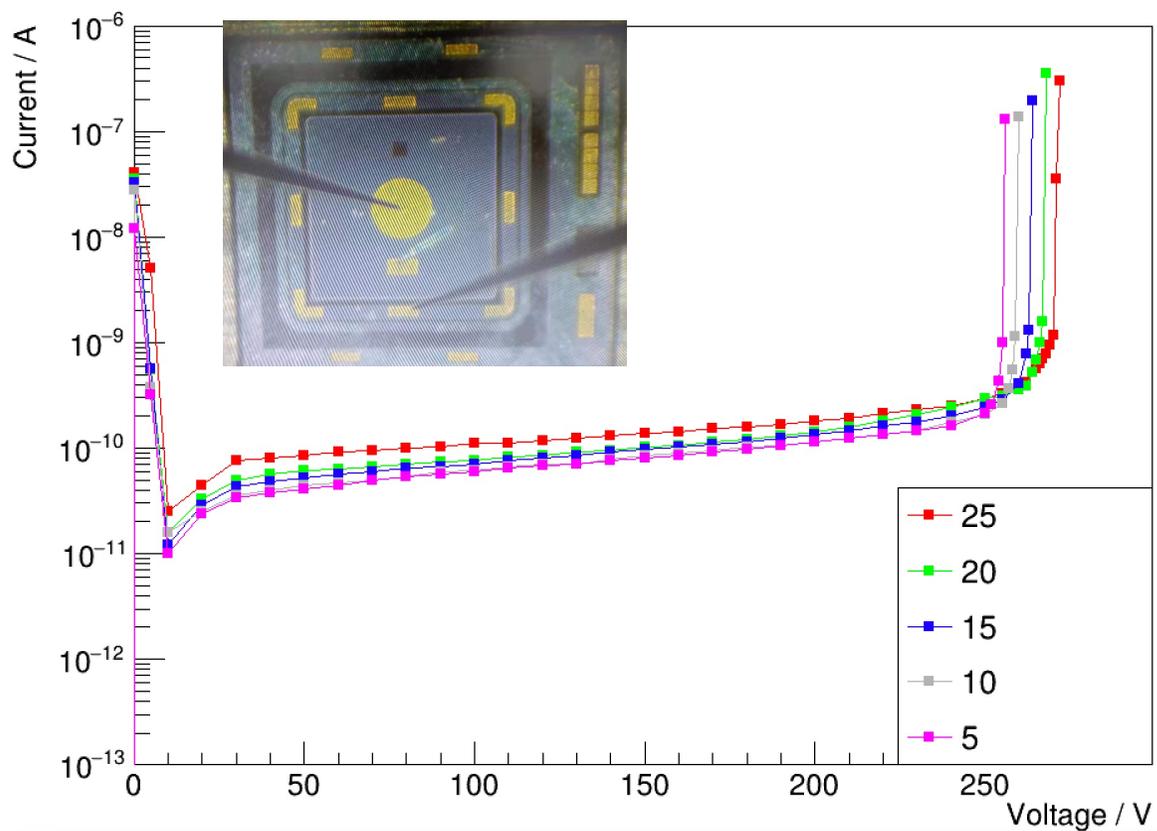
Temperature Dependence Sensor1 test

Temperature dependence I-V test

A temperature-dependent IV test was done on sensor1 and sensor3.

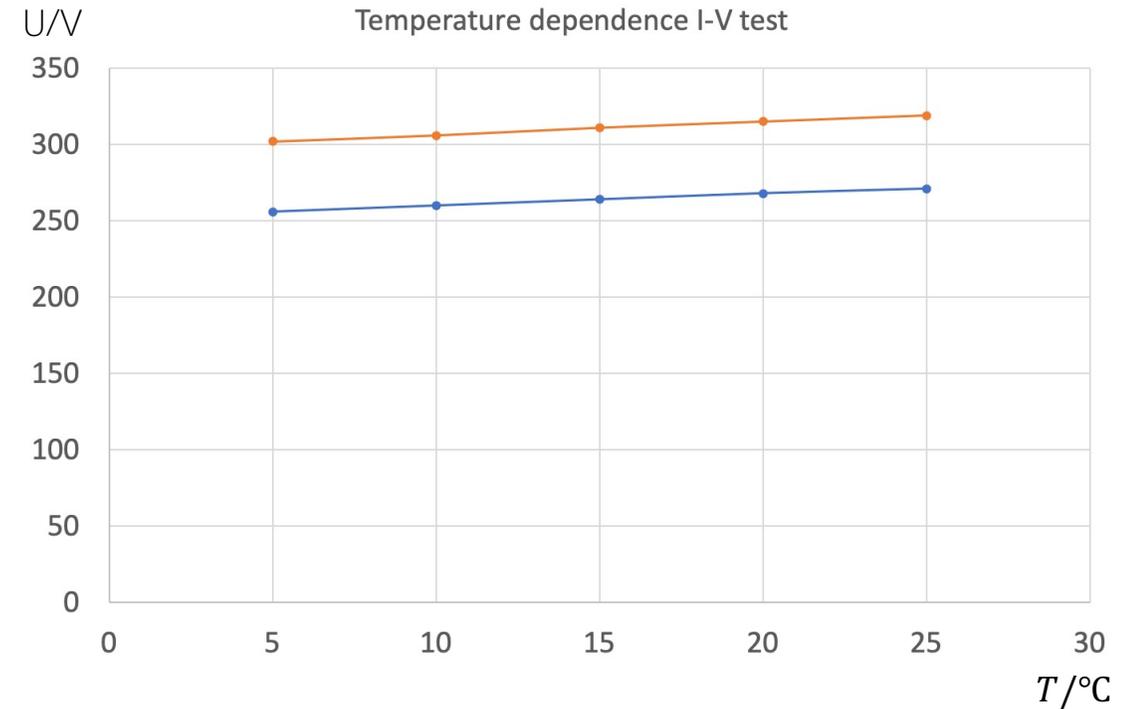
Temperature dependence I-V test

T/D/U °C V	5	10	15	20	25
Sensor1	256	260	264	268	271
Sensor3	302	306	311	315	319

The avalanche voltage increases by 0.8V for every degree of temperature increase.

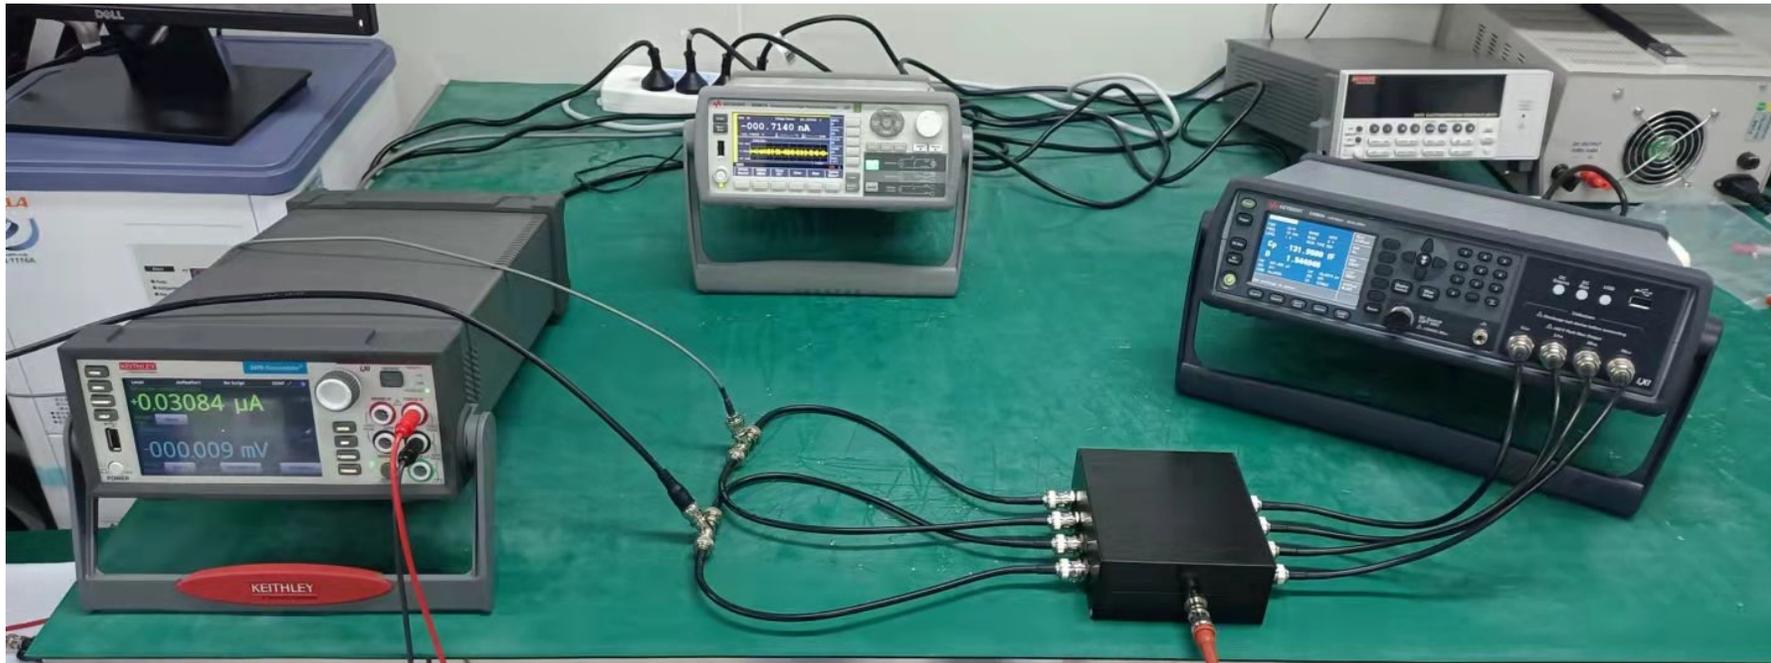
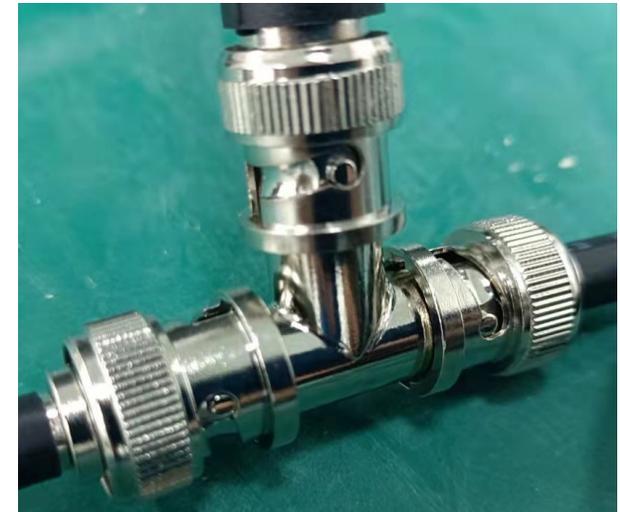
C-V test setup

Replace the 1 m long BNC cables with 30 cm long cables.

The cheap BNC one-turn two-turn T-head was replaced with a pure copper T-head.

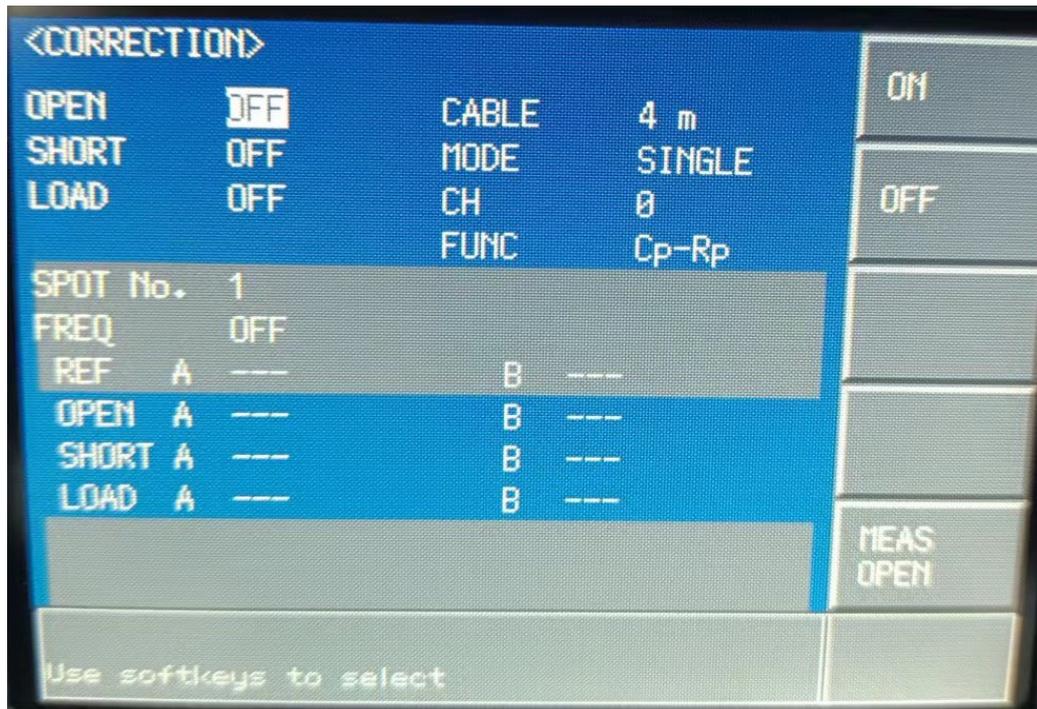
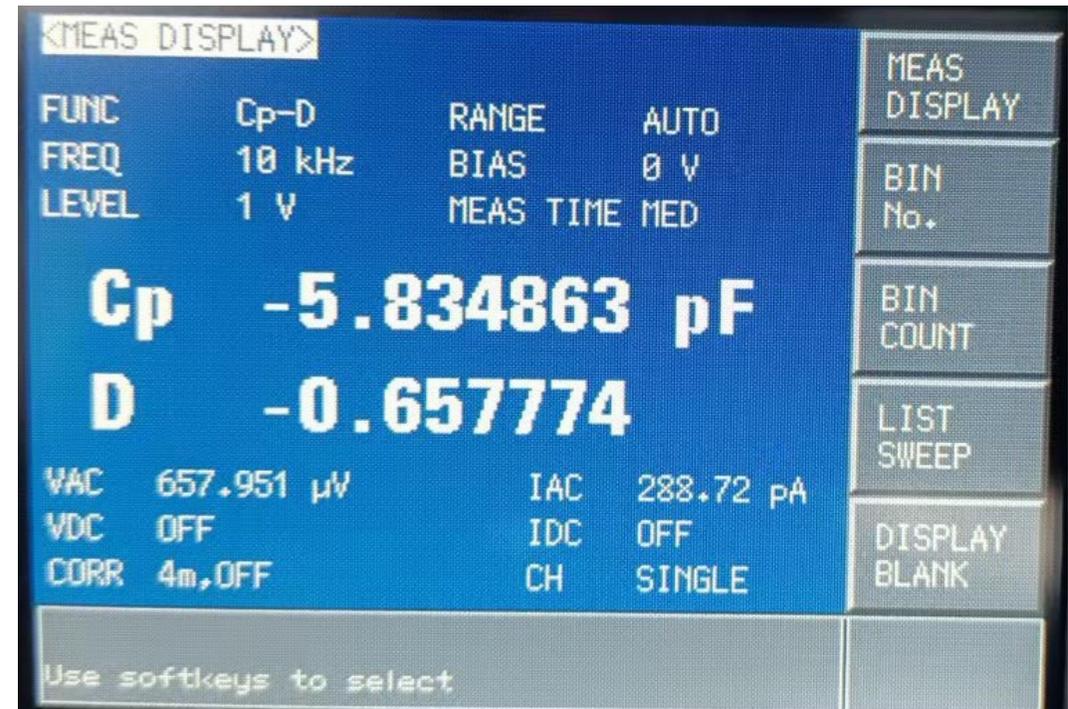
C-V test setup

It is best to OFF the OPEN and SHORT after LCR meter correction. (But I'm not sure.)

There is still a problem here is that the corrected capacitance reading is still negative, but it is more stable than before.

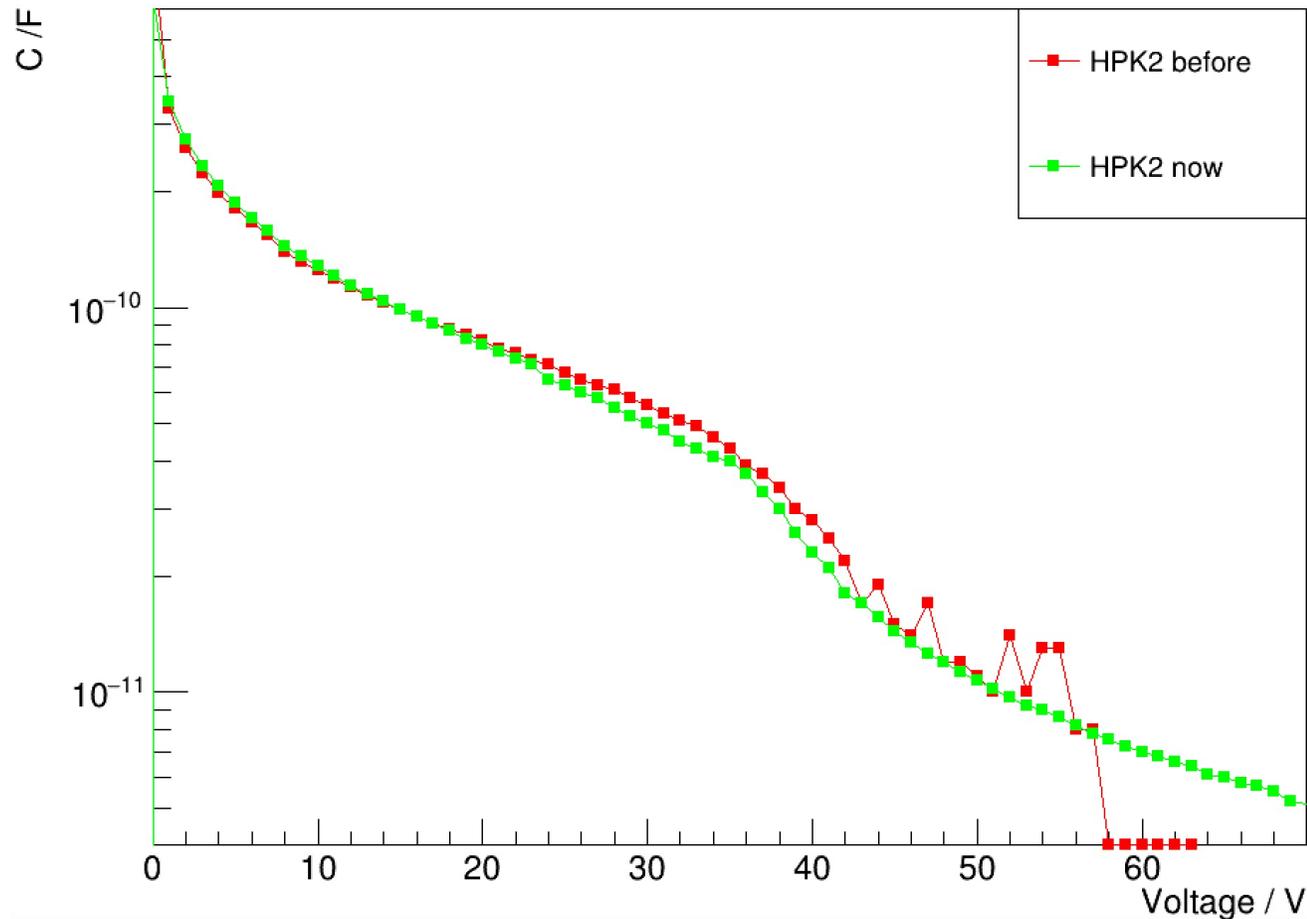
Sensor test

Comparison of previous and current tests

Temperature 21 °C

Temperature 20 °C

The results appear to be consistent.

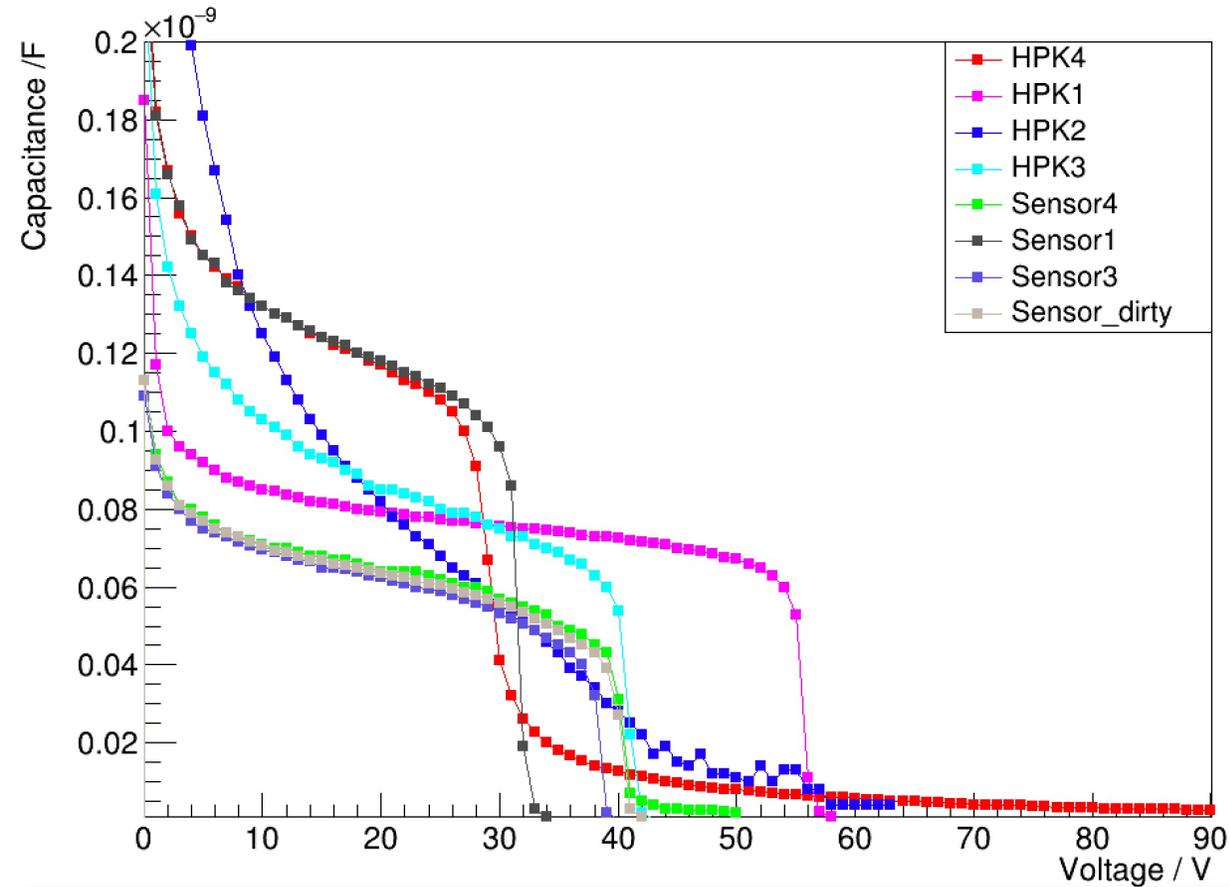
Sensor test

C-V test results

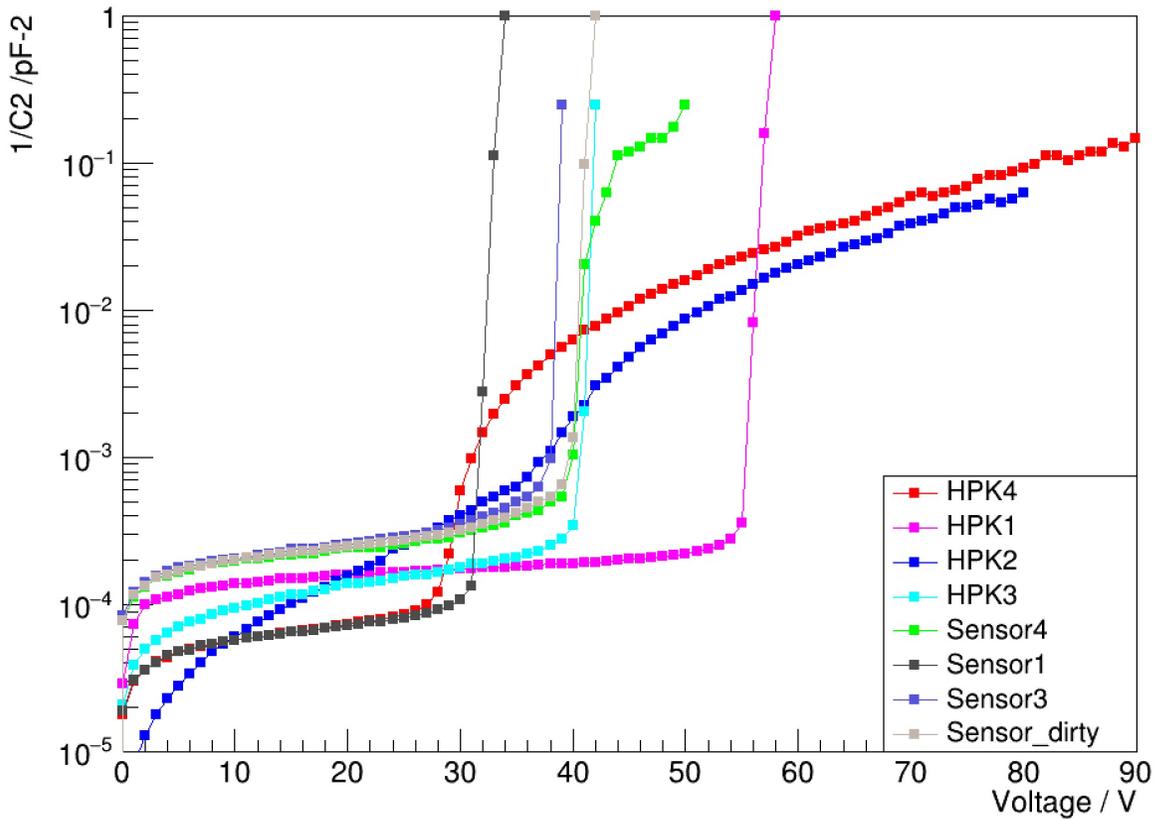
Sensor test

1/C²-V
